APPRAISAL OF REAL PROPERTY

HAZARDOUS MATERIALS ASSESSMENT REPORT

3092 Riverview Road in Rosedale, AB

E3030-B

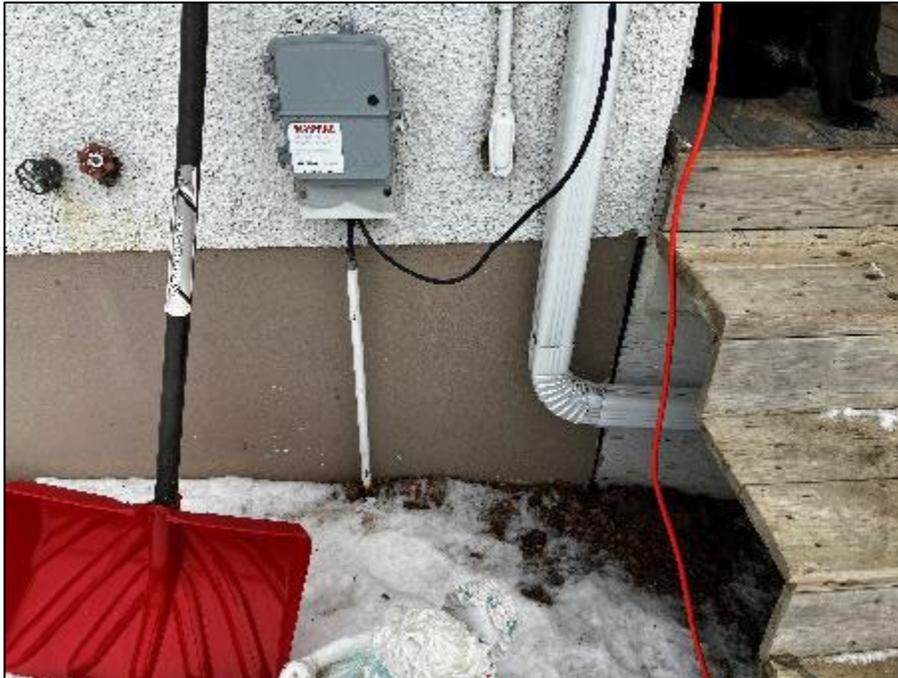
#	DESCRIPTION / LOCATION	ASB TYPE	ASB%	CONDITION	PHOTO
18	Stucco* Exterior – Back	Chrysotile	2%	Fair	18
19	Stucco* Exterior – Right Side	Chrysotile	2%	Fair	19
20	Stucco* Exterior – Left Side	Chrysotile	2%	Fair	20
22	Window Caulking Exterior	Chrysotile	3%	Fair	22
27	Vermiculite Insulation Attic	Actinolite	<1%	Fair	27

PHOTOGRAPH #18: Stucco - Back Exterior (2% Chrysotile)

1. The stucco on the property was identified as asbestos-containing. Any renovation, demolition, or removal of the material must be performed by a qualified abatement contractor using moderate-risk asbestos abatement procedures found in Section 5.3 of the Alberta Asbestos Abatement Manual (2019) (See *Photographs #18-20*).

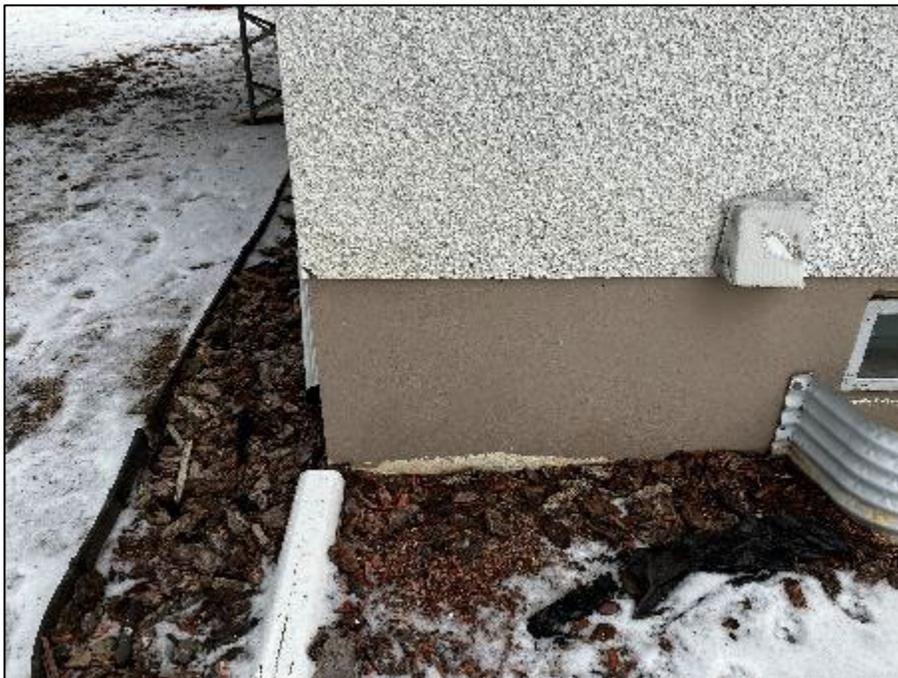
PHOTOGRAPH #19: Stucco - South Exterior (2% Chrysotile)

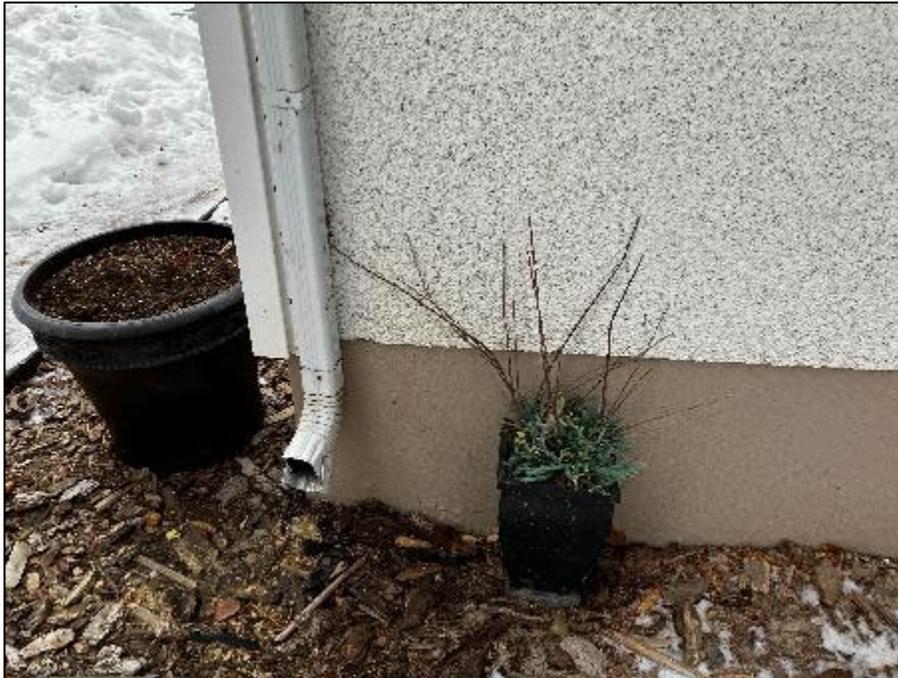
PHOTOGRAPH #20: Stucco - North Exterior (2% Chrysotile)

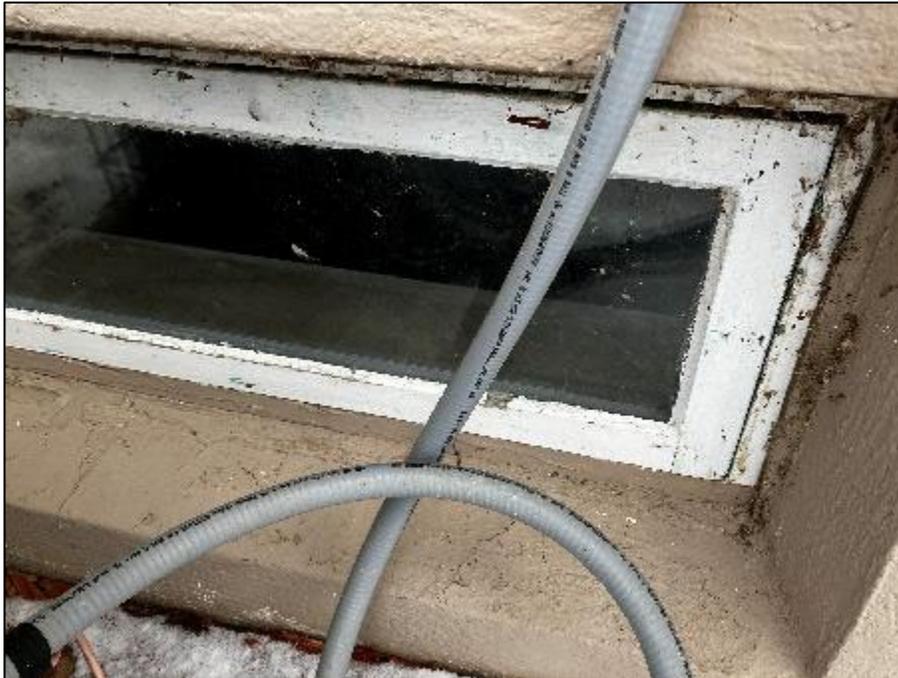
PHOTOGRAPH #22: Window Caulking Exterior (3% Chrysotile)

2. The window caulking on the property was identified as asbestos-containing. Any renovation, demolition, or removal of the material must be performed by a qualified abatement contractor using low asbestos abatement procedures found in Section 5.2 of the Alberta Asbestos Abatement Manual (2019) (See *Photograph #22*).

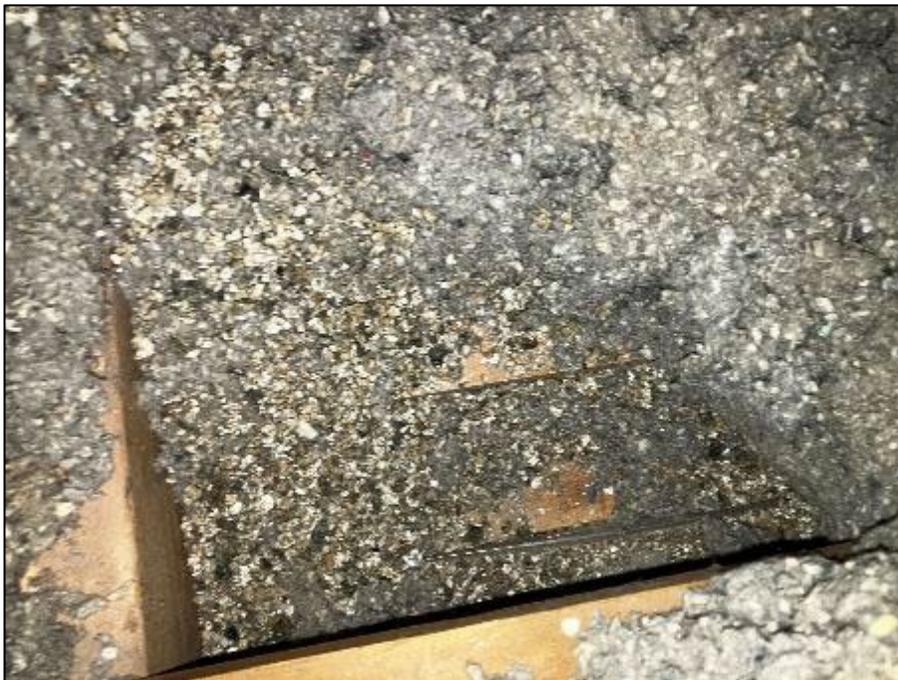
PHOTOGRAPH #27: Vermiculite - Attic (<1% Actinolite)

3. The attic insulation on the property was identified as asbestos-containing. Any renovation, demolition, or removal of the material must be performed by a qualified abatement contractor using high-risk asbestos abatement procedures found in Section 5.4 of the Alberta Asbestos Abatement Manual (2019) (See *Photograph #27*).

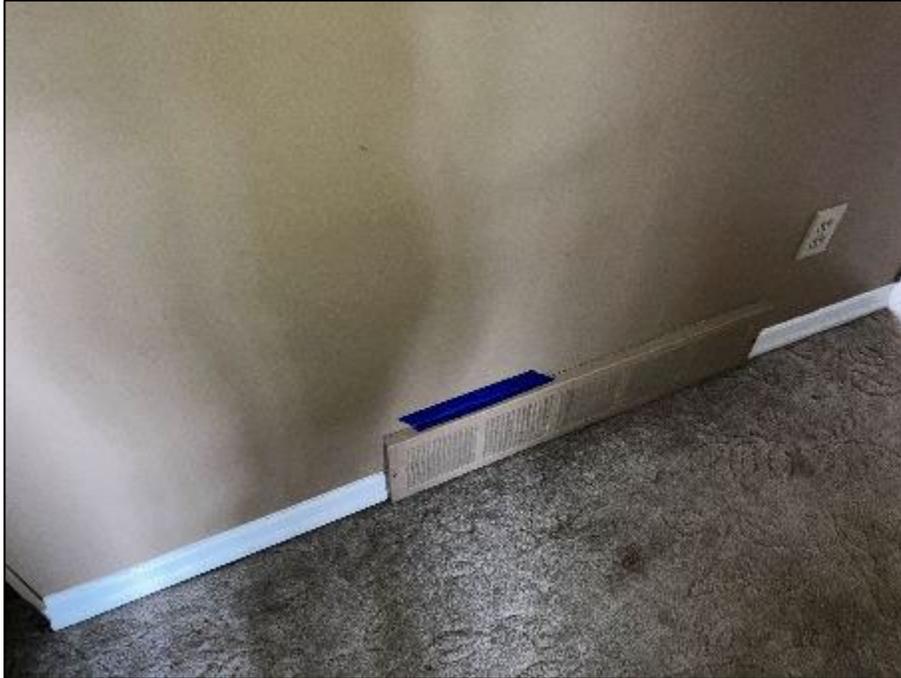
PHOTOGRAPH #28: Paint - Level 1 Hallway Brown (160 ppm Lead)

4. Lead-containing paints (See *Appendix II*) were identified on the property. Disturbance of lead-containing surface coatings should be performed following using exposure prevention controls found in WorkSafeBC's Lead Containing Paints and Coatings: Preventing Exposure in the Construction Industry (2011) document and described in the Alberta Governments Lead at the Work Site (2013) bulletin.

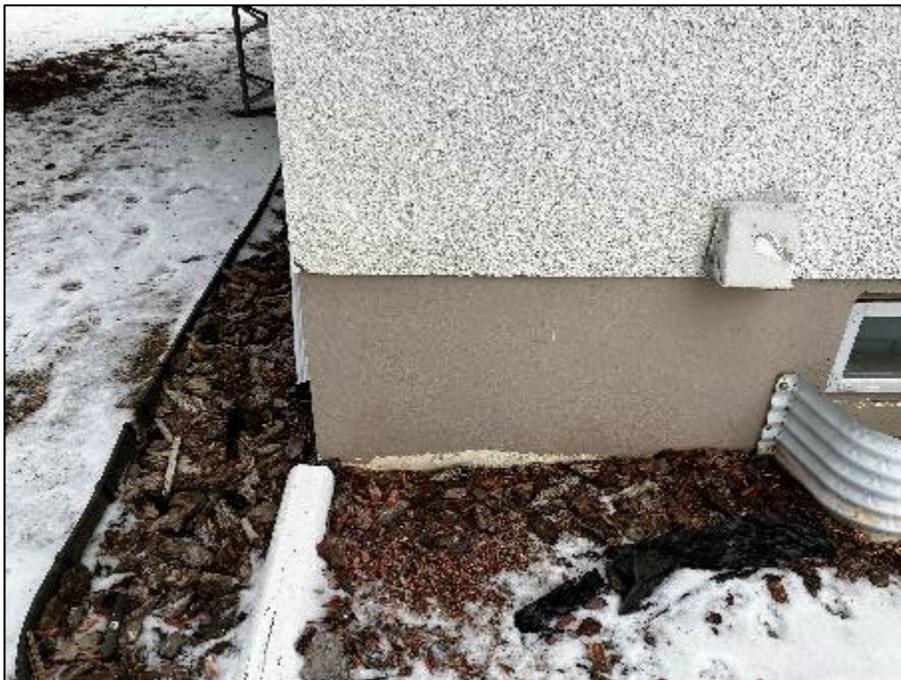
PHOTOGRAPH #29: Paint - Exterior House Brown (670 ppm Lead)

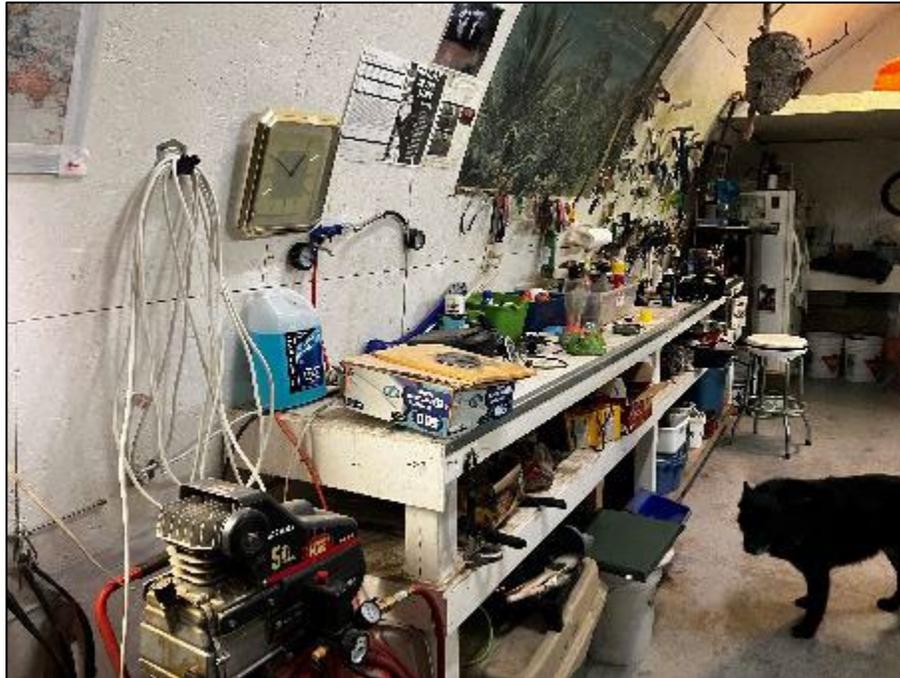
PHOTOGRAPH #32: Miscellaneous Chemicals

5. Hazardous components were identified on site and will require appropriate disposal prior to demolition, including: radioactive materials in smoke detectors, ozone depleting substances in refrigerator, mercury thermostats, and miscellaneous chemicals.
6. Should any new materials be identified throughout the process, work should stop until the materials can be assessed by a qualified health and safety professional.

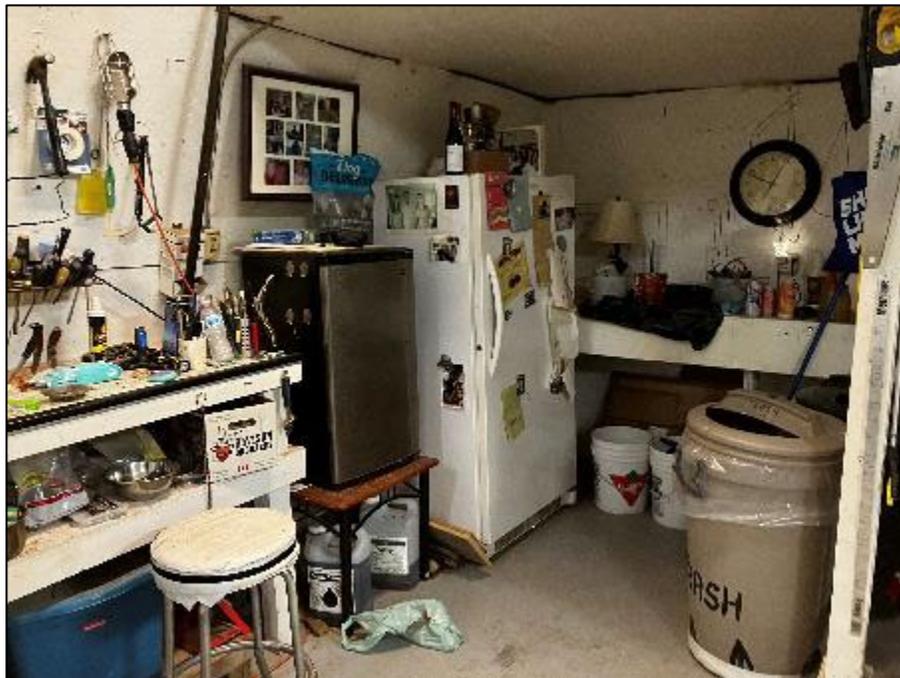
PHOTOGRAPH #33: Fridges

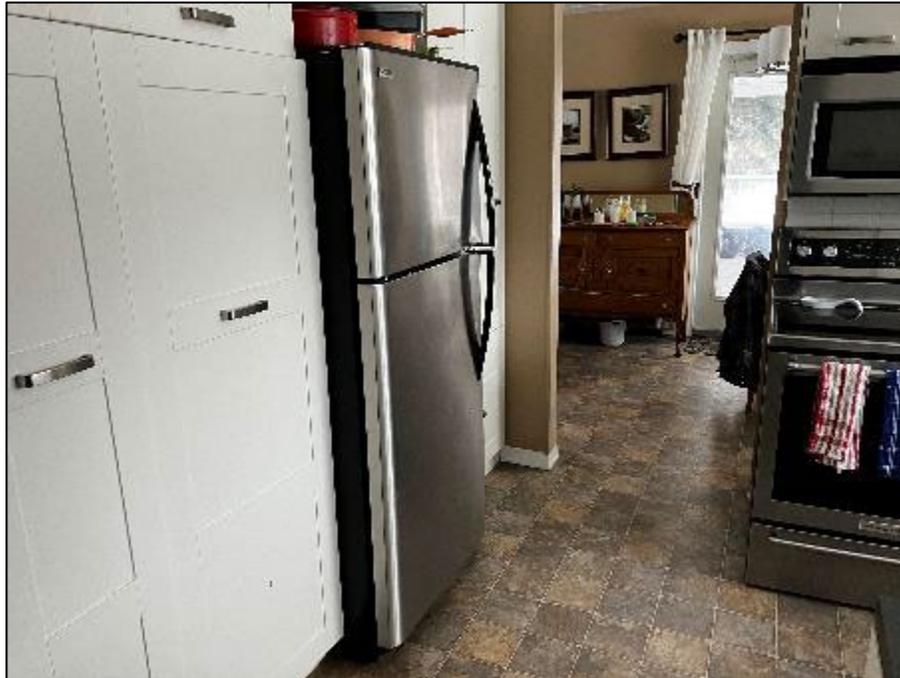
PHOTOGRAPH #34: Fridge in Kitchen

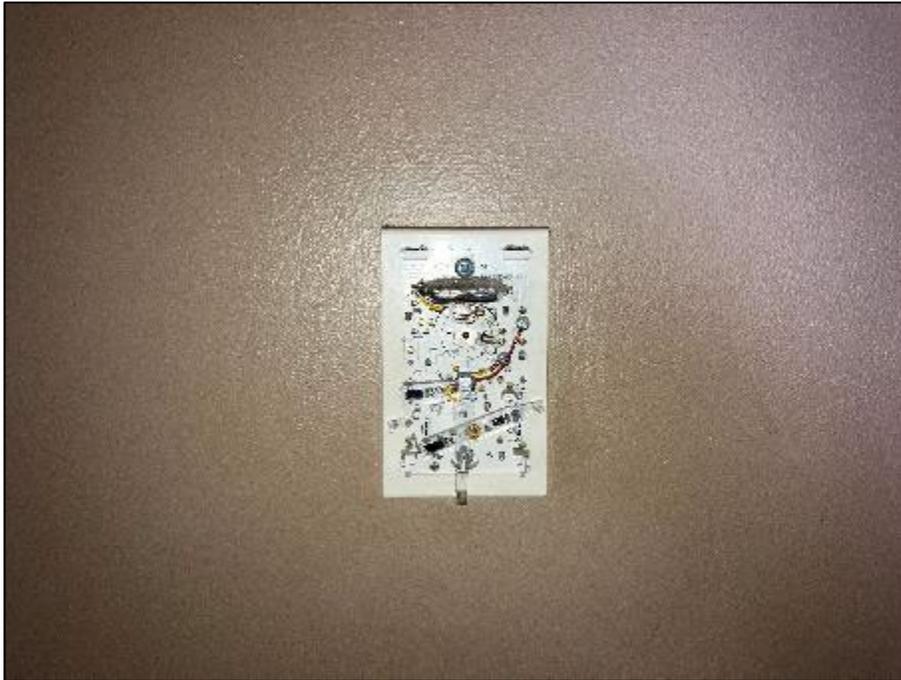
PHOTOGRAPH #36: Thermostat (Mercury)
